Lower Duwamish Waterway Survey of Potential PCB-Containing Building Material Sources

Summary Report

Washington State Department of Ecology
Toxics Cleanup Program
Northwest Regional Office
Bellevue, WA

June 2011

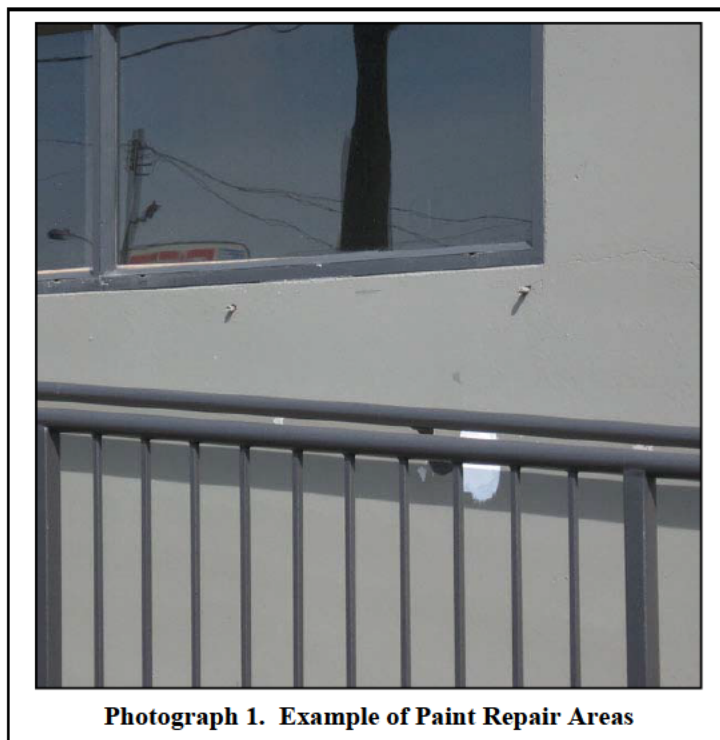
Photograph 1. Example of Paint Repair Areas

Discrete sample areas and test areas were repaired by an Ecology subcontractor after sampling was completed. An example of a paint sample repair area is shown in Photograph 1 while an example of a caulk sample repair area is shown in Photograph 2. The composite samples were then delivered to ARI in Tukwila, WA, in sturdy coolers under ambient temperatures using proper chain-of-custody procedures.

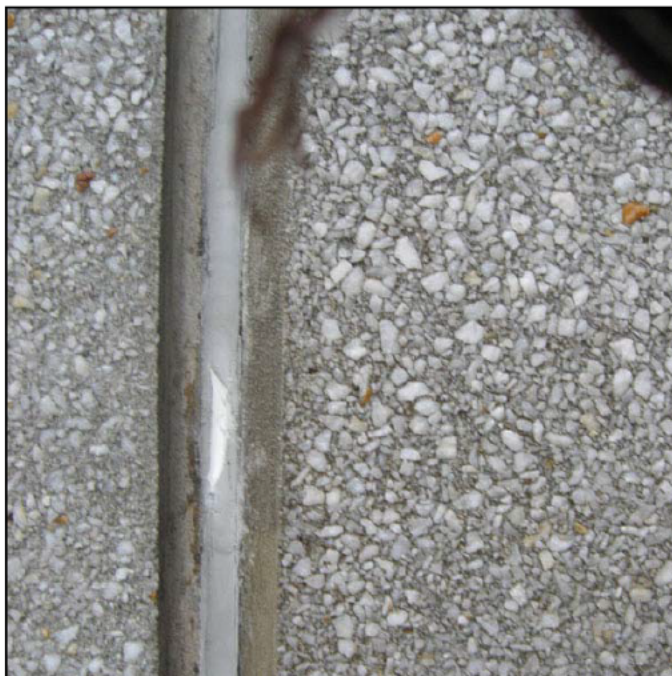
Photograph 2. Example of Caulk Repair Area

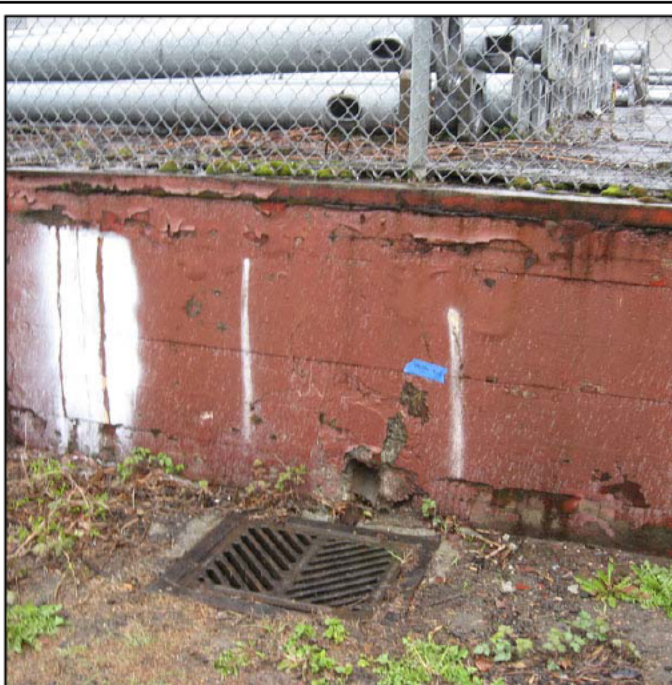
Photograph 3. Example of Peeling Paint Near Storm Drain
